## Fixing S/S Seats in Global Fisher / Stainless Taps.

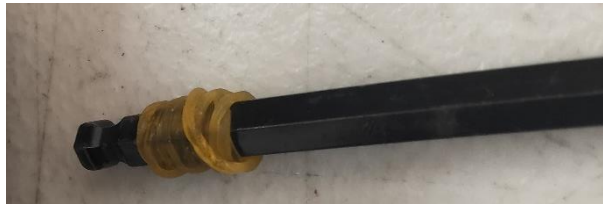
Using a **6mm Alen Key** wrap a rubber band around the base of the end of the Allen key that is going to be doing the work. – See photo.

Screw the seat back into position. --- The rubber Band helps stopping the allen key sliding all the way in and gives purchase to the seat when refitting. --- Tighten up very tight. Clean the inside with rag before next step.
