How To Fix Leaking Pre-Rinse Spray Gun

by Global Tapware P/L

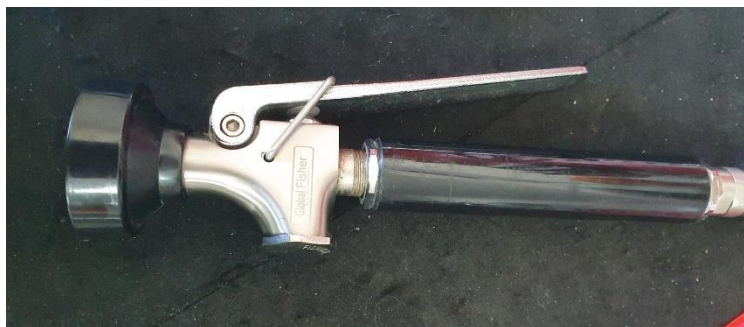
Step 1:-

Turn Water off at the tap.

Then remove Valve Head from Handle.

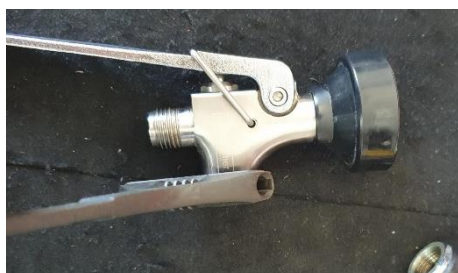
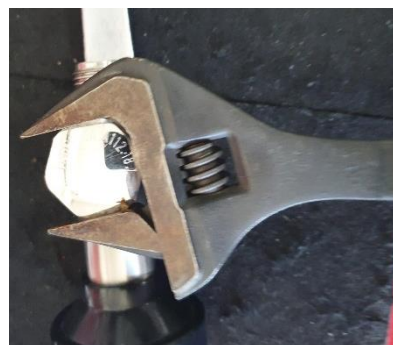
Step 2:-

Using a "Shifter" undo the Hex Nut / Internal Male

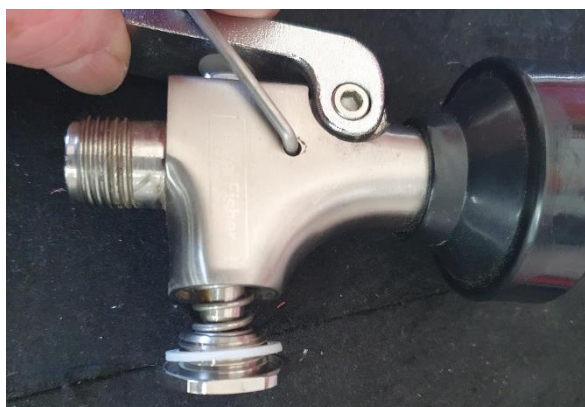
'Take Care' as this fitting is under spring pressure
