HOW TO FIX:-

When the Pre-Rinse Hose Armour-flex starts to come apart / unwind.

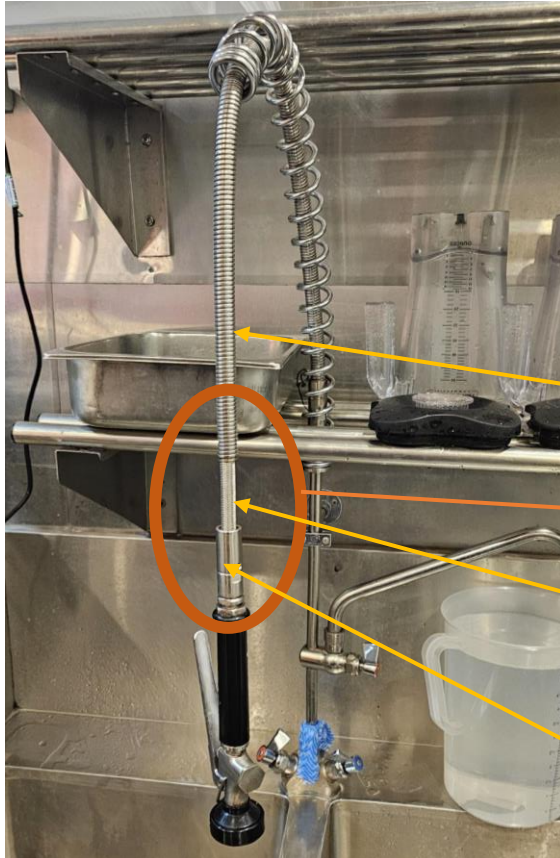
Armour-flex has unwound from the fitting and has exposed the S/S Braided Hose inner Tube.

NOTE – THIS MUST BE FIXED STRAIGHTAWAY

Armour-Flex

S/S Braided Hose

S/S Ferrule

Step One - Turn Water Off and Squeeze Gun Trigger to let water out. This depressurizes the hose.

Step Two – Grad the Armour-Flex Hose and wind it up tight by rotating it ‘Anti-Clockwise’. This will make the gap bigger. You may also need someone to hold the Braided hose as this must stay as it is and not twist.

Step Three - Once the Armour-flex is wound up tight, slide it down to the top of the ferrule. Carefully and SLOWLY – let it start to unwind itself. Once you feel it move freely let it go.

MONITOR this situation – **Check regularly** that it does not occur. If it does re-occur, look for the reason. In this case the spring and hose were jammed up hard to the underside of the shelf, thereby restricting its movement and cause the armour-flex to unwind over a period of time. We ended up changing the Sub Assembly Riser to an Height Adjustable one.

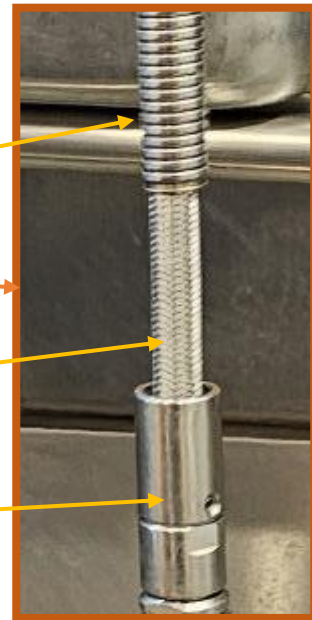
NOTE – There are teeth inside this ferrule for the hose to grab onto.
